October 12, 2020

Version 3

2018-21 Odyssey: Popping or Crackling from the Speakers; No Sound from the Audio System; *Network Loss Message and/or Display Issues*

Supersedes 20-049, dated July 27, 2020, to revise the information highlighted in **yellow**.

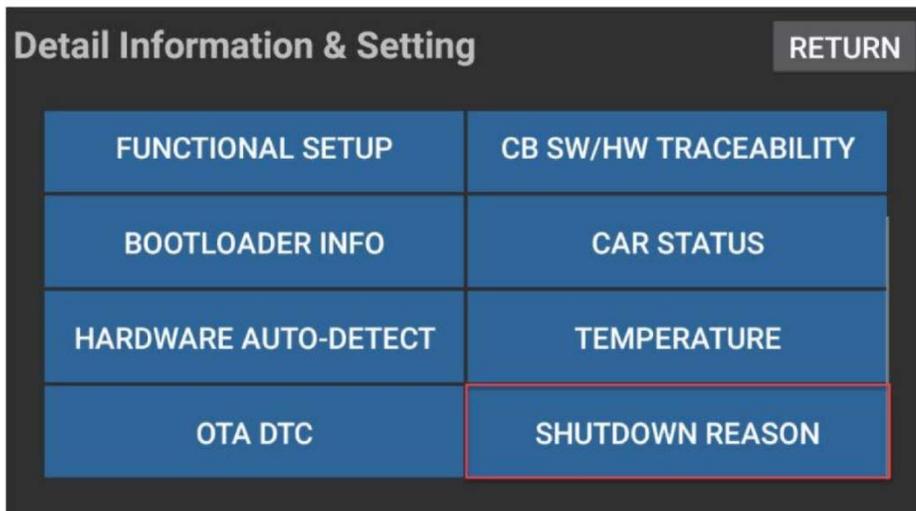
In this example, the cause of the failure can be identified as **Meter:SUDDEN_SIGNAL_OFF**.

Write down any failures; they will be collected on the warranty claim. Then, clear the data.
